Pinpointing concealed
problems inside a resistive-
type OLTC before physical
inspection

CASE STUDY

True dynamic resistance
measurement

Pinpointing concealed problems inside a resistive-type OLTC before physical inspection – Application of True DRM

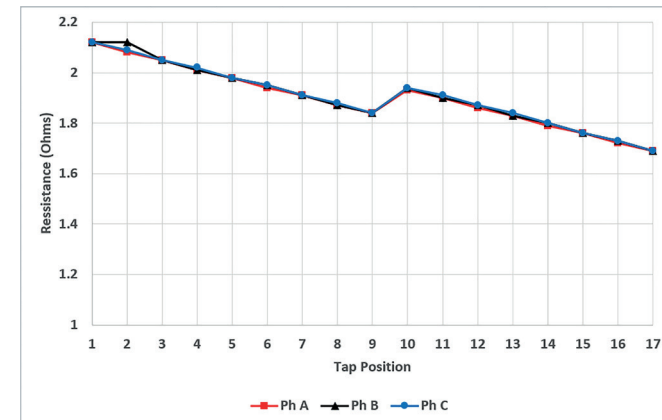
- In this case, the DC WRM on all tap positions (a series of static measurements, Figure 1) shows a very small variation (around 0.2 %) between the three phases and for all taps. This is well within the generally agreed, maximum allowable variation of 2 – 3 %.

Figure 1: WRM results for all 17 taps and all three phases

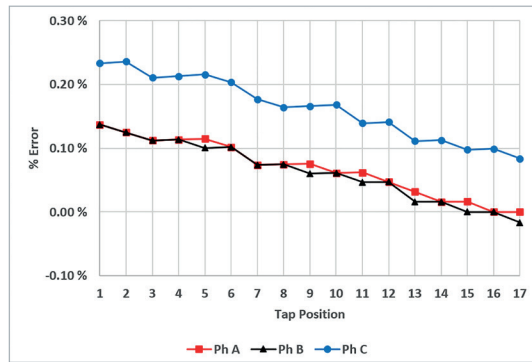
- Looking at the TTR measured values (Figure 2), it was observed that all phases and all taps have a measured ratio well within the generally agreed acceptance value of 0.5 %.

Figure 2: TTR results (% error all 3 phases and all tap positions)

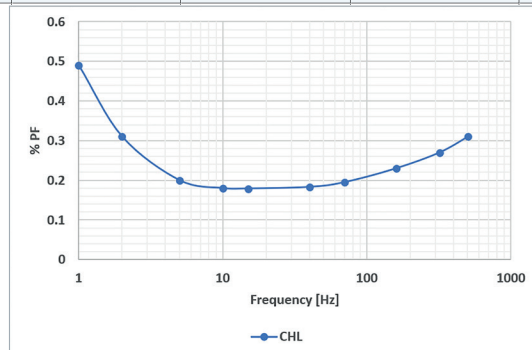
- The Line-Frequency (LF) power factor (PF), or dissipation factor (DF), and NB DFR (narrowband dielectric frequency response) test results (Figure 3) were acceptable. No notable insulation degradation was indicated.

Figure 3: LF PF/DF results and NB DFR plot (1 – 505 Hz)

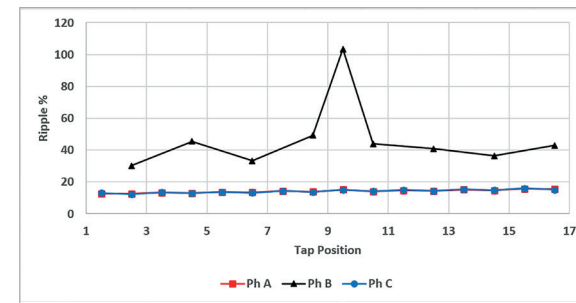
- Advanced OLTC testing was carried out with the Dynamic Resistance Measurement application in the TRAX SW. During the transition from one tap position to the next, the current drops and that is represented by the 'ripple', which expresses the maximum amount that the DC current decreases as a percentage of the test current. The ripple is normally plotted for all phases and taps as presented in Figure 4.

Figure 4: Ripple for each tap transition for all 3 phases

- From Figure 4 the following is observed:
 - The ripples of phases A and C practically overlap each other.
 - The ripple is higher for Phase B and varies much more than the ripples in phases A and C do, the latter which lend to nearly flat lines.
- The ripple graph from phase B may be different compared to the graphs of phase A and/or C due to different induction.
- In this case, the difference in ripples between phases combined with the variance of ripples within Phase B indicate a problem for Phase B.
- DRM analysis provides even more insight than comes from measuring the ripple alone. In a 'true' DRM test, the transition resistors' values are determined with great precision. Figure 5 shows the dynamic resistance for transition 12-13 for Phase C and Figure 6 shows the DRM for transition 13-12 for phase B. Notice the difference in scales on the y-axis (in ohms) of both graphs.

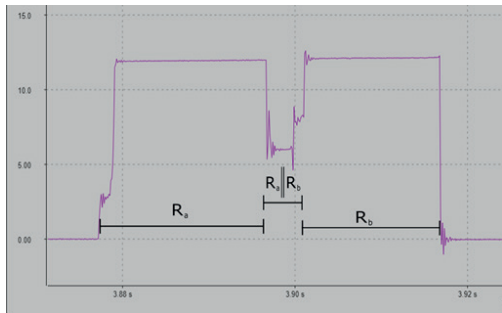
Figure 5: DRM Curve for transition 12-13 Phase C

- Figure 5 is a typical transition DRM response for a 2-resistor switch that has been in service for some time. Resistance values and transition times for both resistors are similar.
- Figure 6 shows something that is far from normal, wherein the apparent resistance goes all the way up to 300 Ω. After 20 ms, the resistance drops to a stable 12 Ω, indicating that the second transition resistor has made contact.
- The DRM test results lead to a much more specific conclusion (than that rendered by the ripple test results alone). The diverter switch operates in both directions; therefore, the fault sometimes comes at the second transition resistance and not at the first one.
- The DRM analysis identifies a problem/deficiency with one of the transition resistors of phase B.

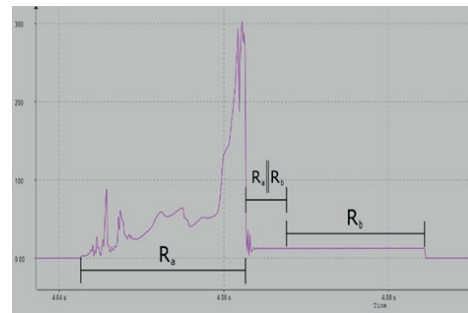
Figure 6: DRM Curve for transition 13-12 Phase B

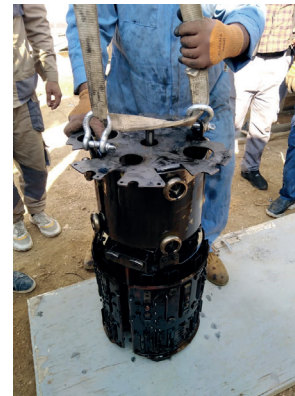
Figure 7: Resistive Type OLTC as removed for inspection

- Based on the DRM analysis, the owner decided to inspect the OLTC thoroughly. After cleaning the OLTC, a loose connector was found (Figure 7).
- The broken contact (Figure 8) was welded back in place (Figure 9) and the OLTC was reinstalled.
- A verification test was performed to verify the OLTC condition after repair. Figure 10 shows the ripple for each transition for all three phases. Now things look normal.

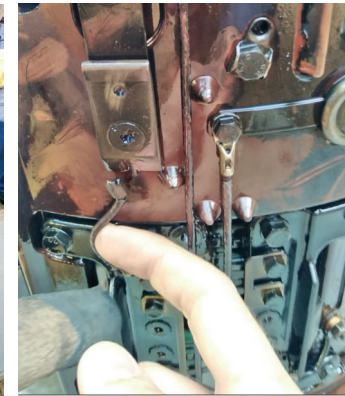
Figure 8: Broken contact for the wire connecting the transition resistors to the transition arcing contact in Phase B

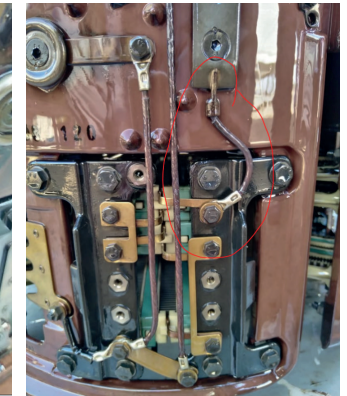
Figure 9: Connection between transition resistors to the transition arcing contact in Phase A (for comparison)

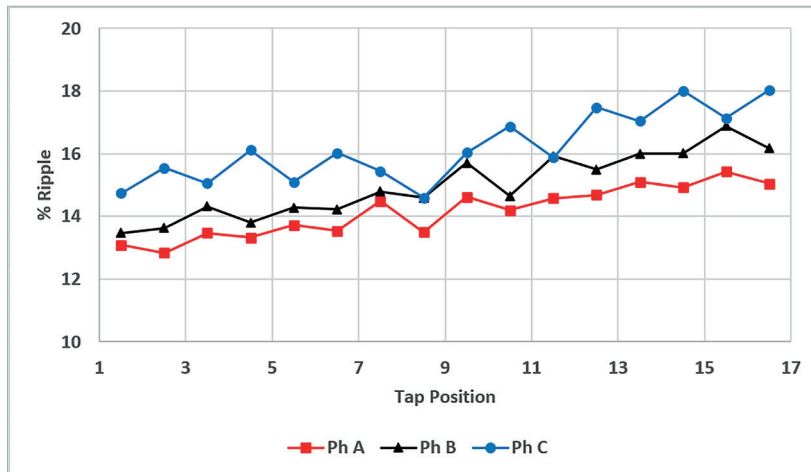
Figure 10: Ripple for each transition after repair

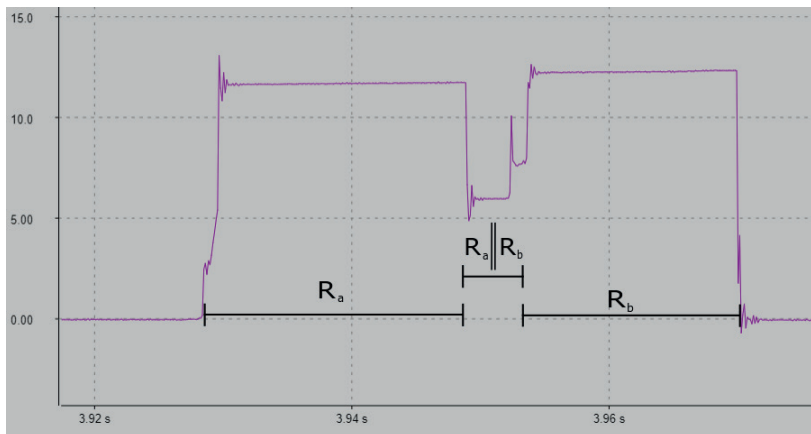
Figure 11: DRM curve for transition 13-12 Phase B after repair.

The true DRM test results obtained on the transition 13-12 for Phase B after repair can be seen in Figure 11. Repairs were successful and the Electric power transmission network in Karbala confidently and safely returned this transformer back to service.
